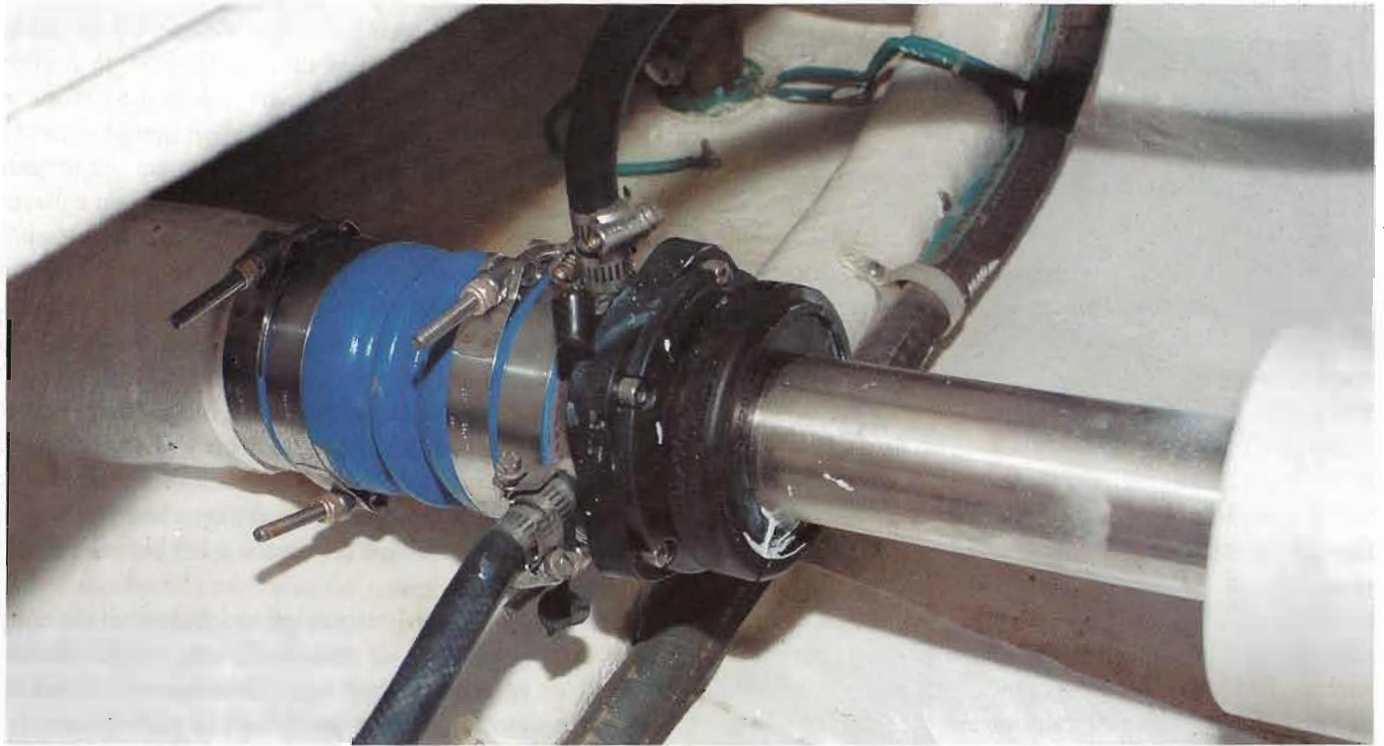
A lip-type seal installed in a twin-screw vessel. This installation includes a spare seal carrier that is located directly forward of the stuffing box. To avoid damage, there should be more separation between these two components; the spare seal carrier spins with the shaft, while the forward end of the stuffing box does not. The dual water injection hoses ensure adequate lubrication in the event that one engine fails and causes one shaft to "windmill" (or spin) while the engine is not running.

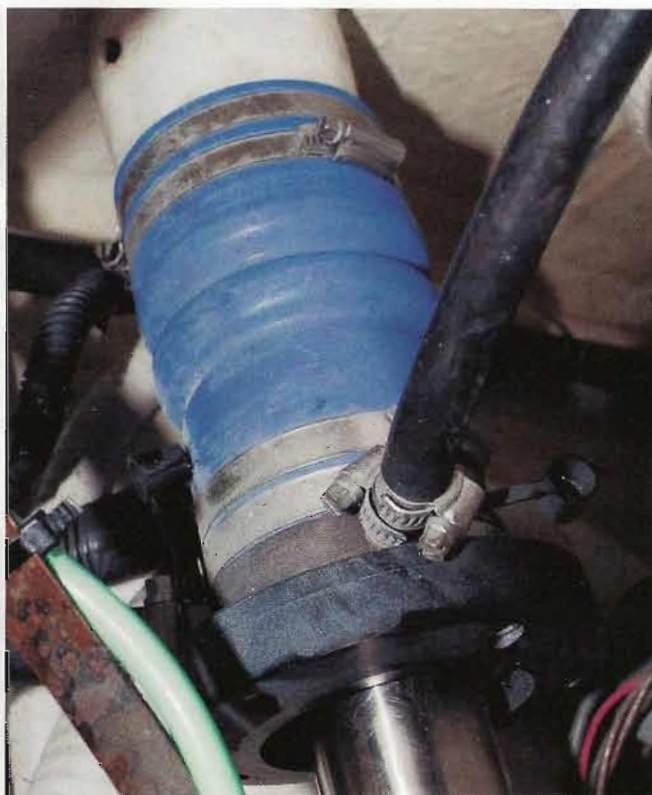
Lip-type stuffing boxes such as the one shown here offer long life and reliable operation, provided they are properly installed and maintained. The manufacturer's installation instructions must be followed to the letter, particularly the specifications concerning the water injection hose and its fittings.

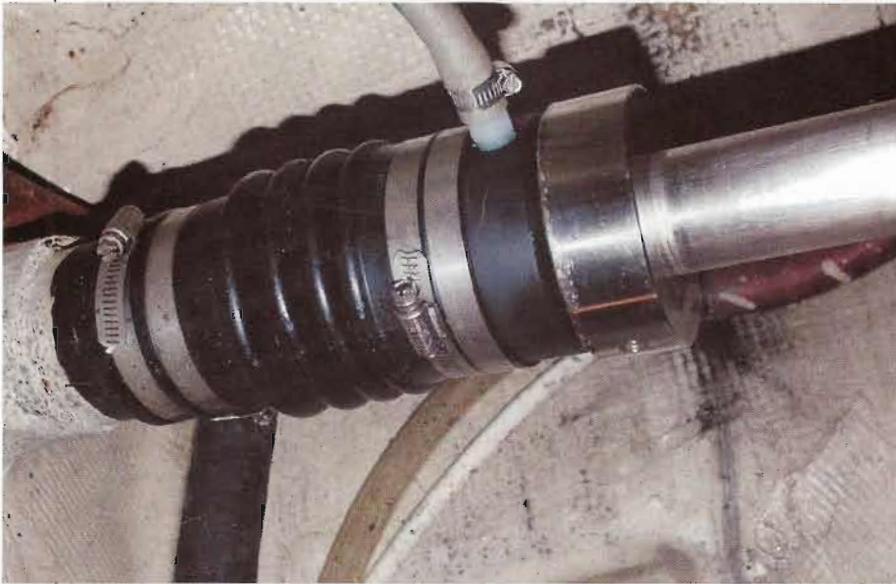
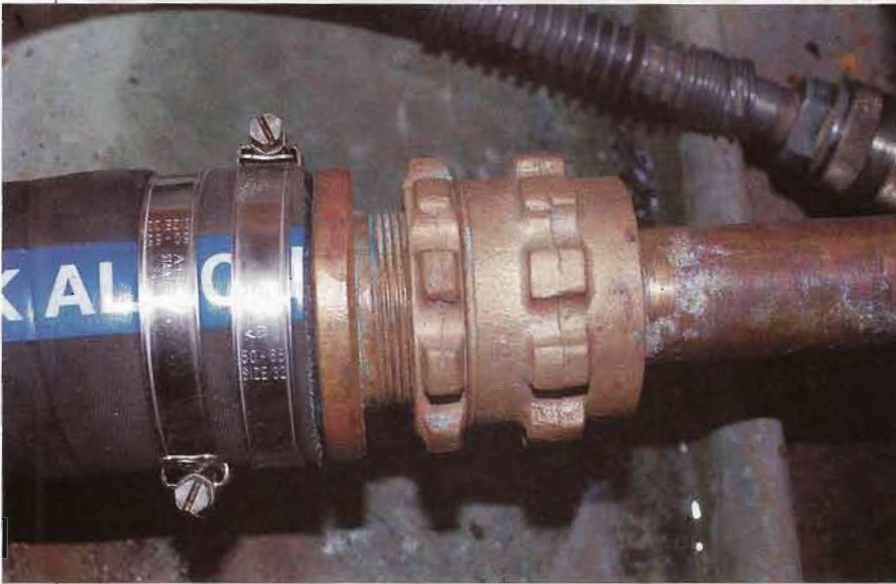
Top: Face-type seals rely on a low-friction, watertight seal created by a spinning stainless-steel ring that is attached to the shaft and a smooth, stationary carbon face seal that is fixed to the vessel through a flexible, tensioned, bellows-style hose. The compression created by the flexible bellows hose plays a key role in this stuffing box's proper, leak-free operation. The bellows must be inspected regularly and replaced periodically. Above: Traditional stuffing boxes may require some leakage in order to operate properly. However, they rarely fail catastrophically, and they seldom require proprietary replacement parts other than correctly sized packing material, proper five-ply hose, and non-perforated all-stainless clamps, all of which are available at any marine chandlery.
